Article

Fiber Bragg Grating Sensors in Three Asphalt Pavement Layers

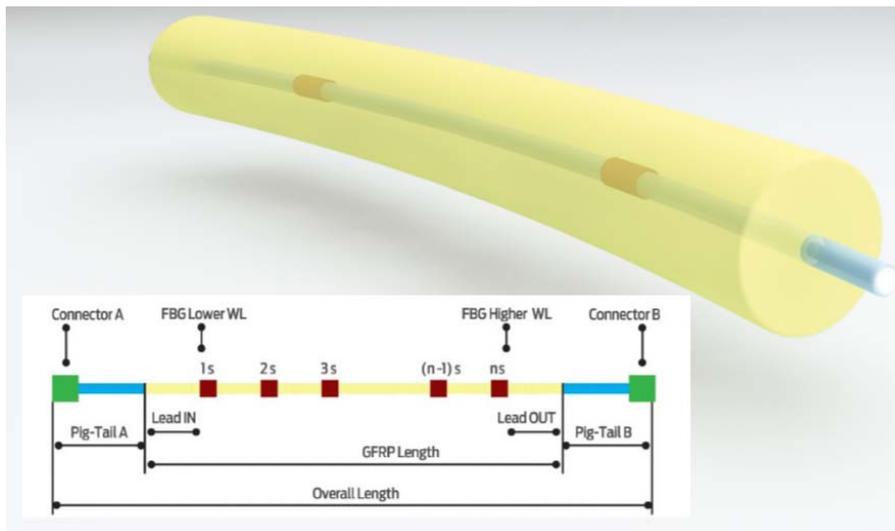
Figure 1. Fiber Bragg grating (FBG) configuration with Draw Tower Gratings (DTG[®]) [15].

FBGs are rather fragile and can break easily under loading; therefore, there is a need for suitable protection of these sensors if they are going to be installed during the rough construction process. For appropriate protection, which guarantees the accuracy of both strain and temperature measurements, in the present study, commercially available, organic modulated, ceramic-coated Draw Tower Gratings (DTG[®]), embedded in a glass fiber reinforced plastic (GFRP) round profile with an outer diameter of 1 mm and protected with an additional high-density polyethylene (HDPE) coating with outer diameter of 0.5 mm, were used (see Figure 1). These DTGs can measure very high strain levels (>10,000 $\mu\text{m}/\text{m}$) and are supposed to show an excellent long-term stability under mechanical fatigue conditions. Draw Tower Gratings (DTG[®]s) are produced during the drawing process of the fiber itself, before the primary coating is applied. Considering that it is a cost-effective production process for high quality fiber Bragg gratings, it offers unique characteristics, such as extremely high breaking strength, an operational temperature range of up to 200 °C (for ORMOCER[®]), insensitivity to bending, spliceless array configurations, and uniform coating coverage, which are very important for application of these fibers in asphalt pavement.

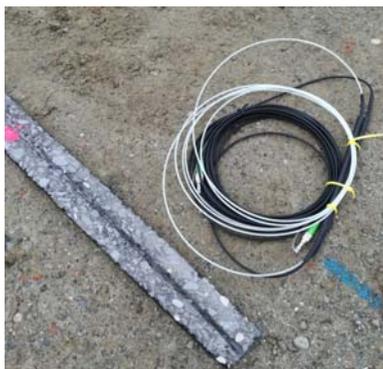
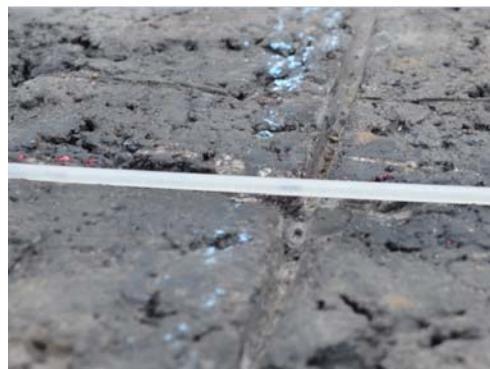
Figure 2. Installation of FBGs in prefabricated asphalt in the base layer (a) and installation of FBGs in the previously constructed asphalt layer (b).

In the present study, FBG chains of 30 DTG[®] (1529.7–1567.4 nm) and 5 DTG[®] (1530–1558 nm) were selected for installation in each of three superimposed asphalt layers (the surface layer and both base layers). The FBGs were placed in a cross-section configuration in order to carry out measurements in two directions—transverse and longitudinal directions (in a bicycle path with width of 4 m and length over 3.2 m) (see Figure 2b). The asphalt mix was applied at a temperature between 120 and 160 °C. It was very important to allocate each fiber at the bottom of each layer in transverse (T) and longitudinal (L) directions. Two new approaches to FBG installation in three asphalt layers were tested: (1) installation of FBGs in prefabricated asphalt in the bottom of the base layer (see Figure 2a) and (2) installation of FBGs in the surface of the previously constructed asphalt layer (see Figure 2b). Both innovative approaches allow the implementation of FBGs without sawing the whole layer into two parts. The FBG configuration is shown in Figure 3.

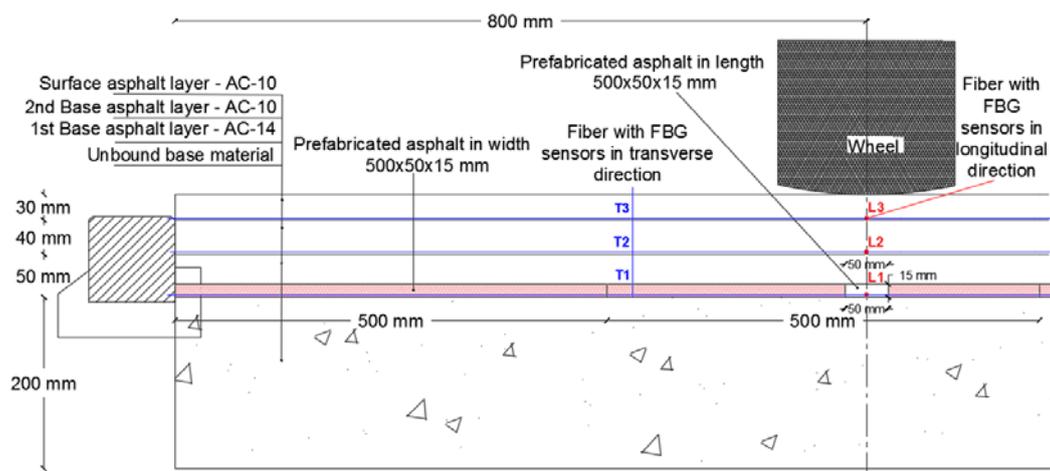
- T1—FBG chain of 30 DTG® in the transverse direction at the bottom of the base asphalt layer AC-14 (12 cm depth);
- T2—FBG chain of 5 DTG® in the transverse direction at the bottom of the base asphalt layer AC-10 (7 cm depth);
- T3—FBG chain of 5 DTG® in the transverse direction at the bottom of the surface asphalt layer AC-10 (3 cm depth);
- L1—FBG chain of 30 DTG® in the longitudinal direction at the bottom of the base asphalt layer AC-14 (12 cm depth);
- L2—FBG chain of 5 DTG® in the longitudinal direction at the bottom of the base asphalt layer AC-10 (7 cm depth);
- L3—FBG chain of 5 DTG in the longitudinal direction at the bottom of the surface asphalt layer AC-10 (3 cm depth).

Figure 3. FBG configuration in three asphalt pavement layers (cross-section of road) [16].

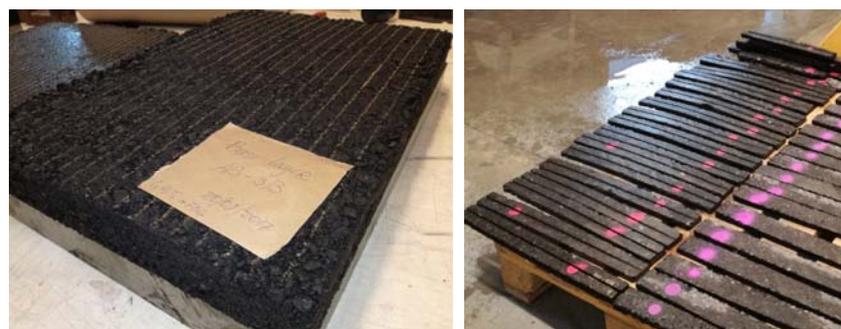
Figure 4. Prefabricated asphalt (AC-14) specimens with grooves for preparation of FBG embedment.

After an extensive literature review study, it was concluded that the protection of sensors is an ongoing challenging issue to deal with, especially the protection of FBG sensors installed at very high asphalt temperatures and during heavy compaction loadings. Several protection measures, including fiber reinforced polymer (FRP), steel tubing, and carbon fiber reinforced epoxy resin coatings, have been shown to be able to provide adequate protection. However, in order to guarantee the survival of FBGs during the installation process in the base asphalt layer in this case study, it was decided to embed them in prefabricated asphalt specimens (see Figure 4) and adjust on-site during the construction process.

For this first approach to FBG installation, asphalt slabs with dimensions $600 \times 400 \times 50$ mm were produced under laboratory conditions, with the same asphalt mix composition as the base layer used during the bicycle path construction process. The slabs were sawn into specimens with dimensions $500 \times 50 \times 15$ mm, and a groove with a depth of 2 mm was made in each specimen. The FBGs were positioned in a groove of the prefabricated asphalt specimens on-site and covered with a thin layer of mastic to keep FBGs in the desired position inside the groove. Prefabricated asphalt specimens were connected to each other on-site by gluing them together with a layer of mastic. Prefabricated asphalt

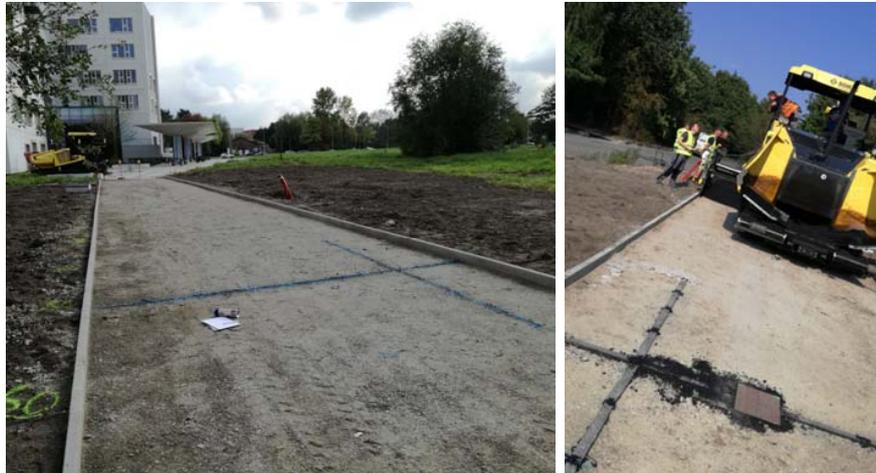
Figure 5. Installation of FBGs in the base asphalt layer directly on the base (first approach).

specimens were placed with the groove facing down on the unbound material base layer. In order to avoid collapse of the prefabricated asphalt specimens, steel plates with dimensions of $340 \times 300 \times 5$ mm were placed on top of the specimens during the construction process when the asphalt truck and the paver were driving over them (see Figure 5).

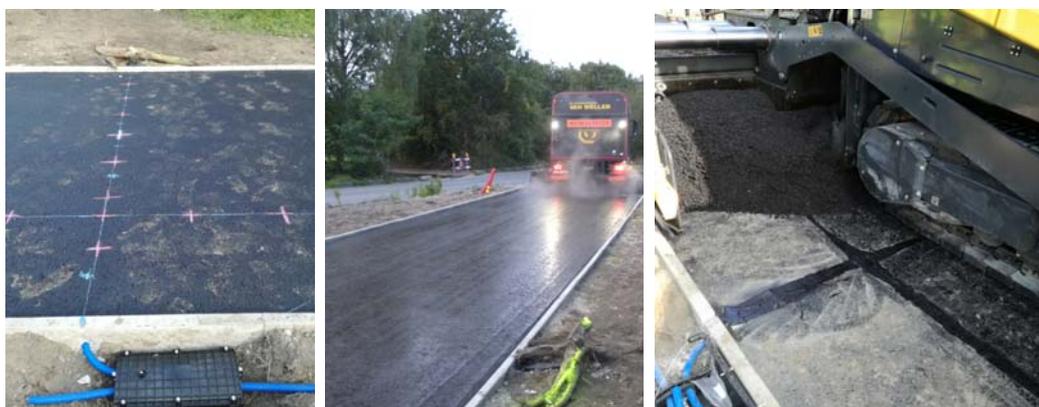
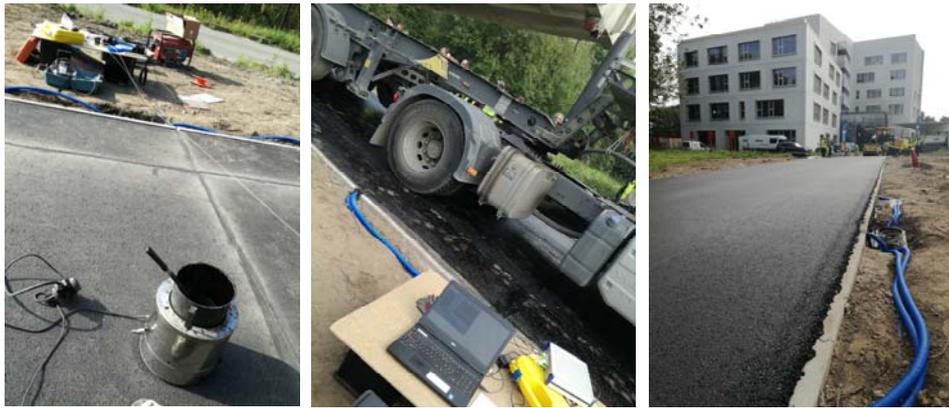
Figure 6. Installation of FBGs in two asphalt base layers (second approach).

The installation of the FBG monitoring system was a part of a larger project—CyPaTs (www.uantwerpen.be/cypats), in which a bicycle path (length—96 m and width—4 m) was accomplished over 3 days (one asphalt pavement layer per day). During the first day, FBGs (T1 and L1) were installed in the prefabricated asphalt specimens, and the first strain measurements were carried out after the first base layer (AC-14) was laid down. FBGs (T2 and L2) were installed in grooves (in the upper section of this base layer) after 2 h on the same day. In order to ensure the bonding of the interfaces between asphalt layers, a tack coat was applied (see Figure 6). During the second day, FBGs (T1, T2, L1, L2) were monitored during construction of the second base layer (AC-10) while the asphalt truck and the paver were crossing the sensing zone. FBGs (T3 and L3) were installed in grooves after 2 h on the second day. During the third day, all FBGs in T and L directions were monitored during construction works. The strain and temperature data were obtained using an interrogator FBG-SCAN 808D with eight channels (1510–1590 nm wavelength range, 250 Hz measurement speed for all channels).

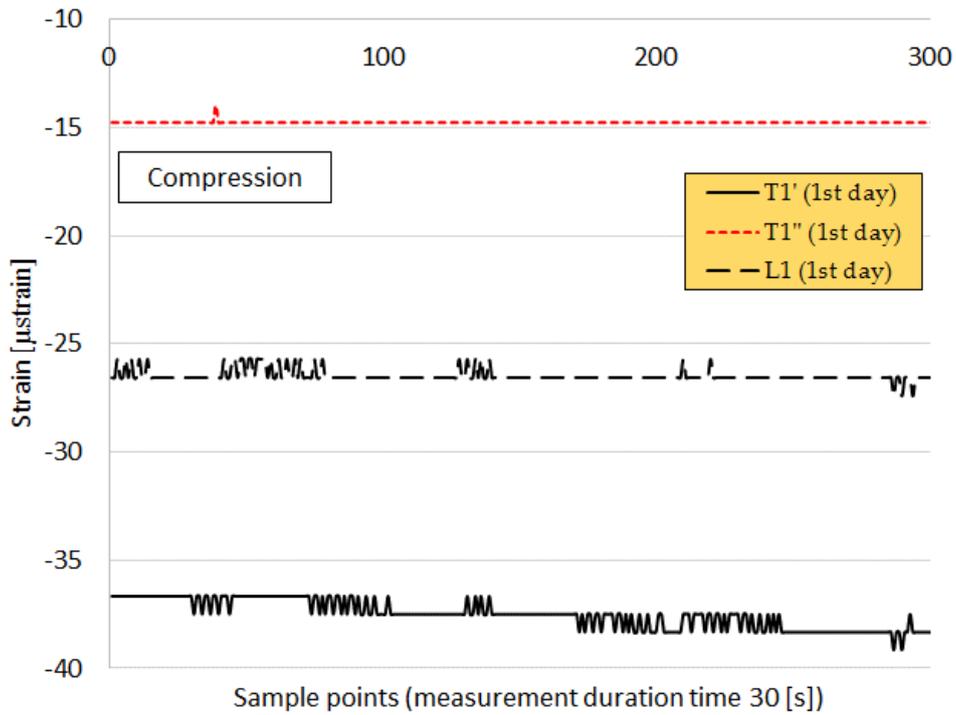
Figure 7. Strain values of sensors T1', T1'', and L1 during the construction of CyPaTs asphalt pavement on the first day at a temperature of 64 °C on the surface of the first base layer AC-14.

The response of the sensors (strain vs. time) during the construction process can be seen in Figures 7–15, where the sensors show a positive shift (tension) or negative shift (compression) during loading. The first registered response of the sensors with no loading 2 h after the installation of the first base layer (AC-14) is shown in Figure 7. With this technology, it was demonstrated that the deformations in the structure can be monitored very accurately; for example, during monitoring, it was observed that axle loading was not equally distributed, and that the response of the sensors under the right wheel (T' —black line) had higher values than those under the left wheel (T'' —red line) of the four-axle truck and paver. Considering this, two sensors from each fiber in the transverse direction were considered for the analysis: one sensor (T') under one loading point (in the center beneath the wheel) in the three asphalt layers in T direction, and another sensor (T'') closer to the edge of the road during the 3-day paving process. In Figure 7, it is clear that the responses of $T1'$ and $T1''$ show a difference in strain value, meaning that one side of the road is under higher compression than the other side.

(see Figure 7), under tension on the second day, and under compression–tension on the third day, when the top layer was laid down.

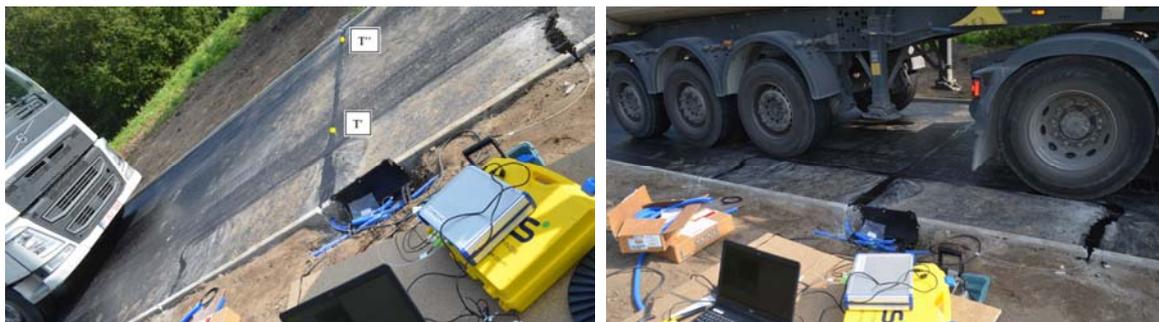
Figure 8. Monitoring of FBGs during the second day during the construction of the second base layer of the CyPaTs bicycle path.

During the construction of the pavement on the second day, it was requested to drive the truck and paver over the sensing zone in such a way that the right wheels drove along the FBGs in the L direction. In Figure 8, it can be seen that this was almost achieved. It was observed that, during construction process, one side of the road was always overstressed compared to the other side. This different compaction grade can eventually lead to different deformation behavior, although the same asphalt mix was used for this section.

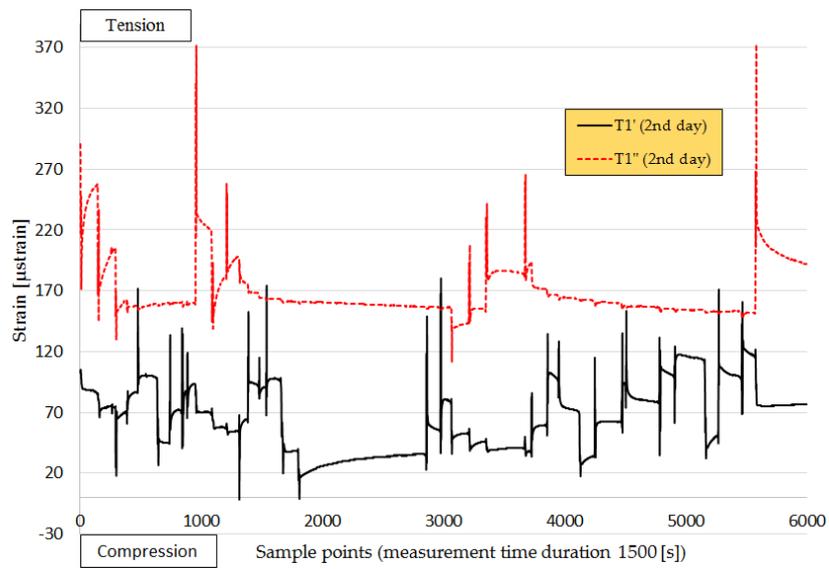
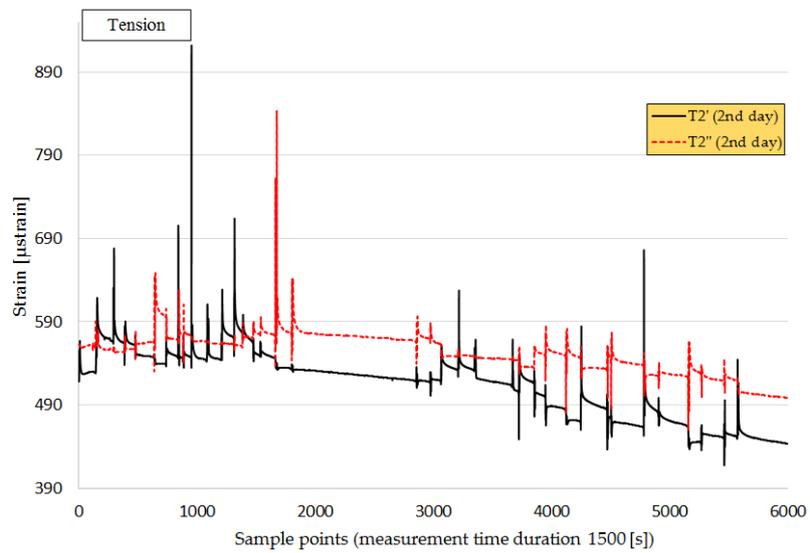
Figure 9. Strain values of sensors: (a) T1' and T1'' and (b) T2' and T2'' during the construction of CyPaTs asphalt pavement on the second day.

The response of the sensors under loading of both a four-axle truck and paver during the construction of the second base layer (AC-10) is shown in Figure 9. In Figure 9a, the response of the sensors (measurement time—1500 s, sample points—6000, sample time—0.4) under the loading of a truck (sample points—0..2000) followed by the loading of the paver (sample points 3000..6000) is given. It can be also noticed that the highest strain value in the first base layer (AC-14) is approximately

370 μ strain in tension in the T1'' sensor zone and around 170 μ strain in the T1' sensor zone. In Figure 9b, it can be observed that the sensor zones T2' and T2'' on the top of first base layer (AC-14) during construction have smaller differences in strain values compared to each other, but almost 2-fold higher values in comparison to the strain values on the bottom of the first base layer (AC-14). The temperature on top of the first base layer (AC-14) was 24 °C before the second base layer was laid down and 29 °C during the paving process (sample points 4000..6000).

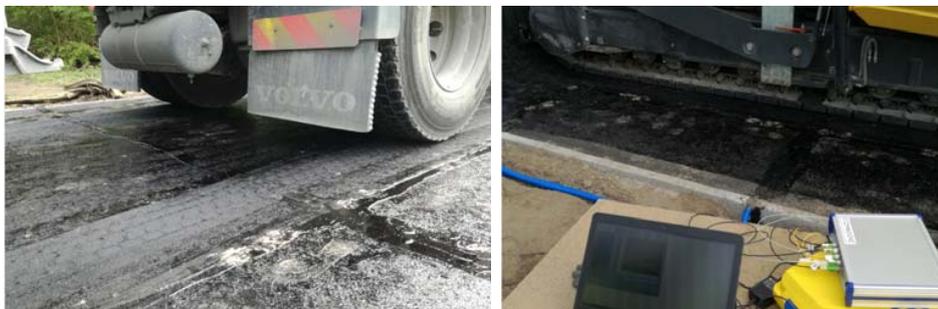
Figure 10. Monitoring of FBGs on the third day during the construction of top layer of the CyPaTs bicycle path at a temperature of 24 °C on the surface of the second base layer AC-10.

In Figure 10 is shown monitoring of the FBGs during the construction of the top layer (AC-10). In Figure 11, an overview is given of the response of the FBGs in the three asphalt layers under the loading of both truck and paver during the pavement construction on the third day of paving, when the top layer (AC-10) was laid down. The response of the sensors in the location T1 indicates mostly tension of the fiber, with a maximal strain value of 320 µstrain when the truck fully loaded with asphalt crossed the sensing zone with its first axle. The obtained value is 10% less in comparison to the response of the same sensor in the location T1 on the second day, which indicates that the asphalt pavement stiffened. The response of the sensors in the location T2 indicates mostly compression, with a maximal strain value of 890 µstrain when the paver crossed the sensing zone. The response of sensors in the location T3 indicates mostly tension, with a maximum value of 490 µstrain when the paver crossed the sensing zone. The temperature on top of the first base layer (AC-14) was 21 °C before and during the laying of the top layer. The temperature on the top of the second base layer (AC-10) was 24 °C before the paving process; during the paving process of the top layer, it increased to 29 °C within the time interval of 300 s. One hour after the top layer (AC-10) was paved, the temperature under the second base layer (AC-10) decreased to 22.3 °C, and under the top layer (AC-10), a value of 68 °C was reached.

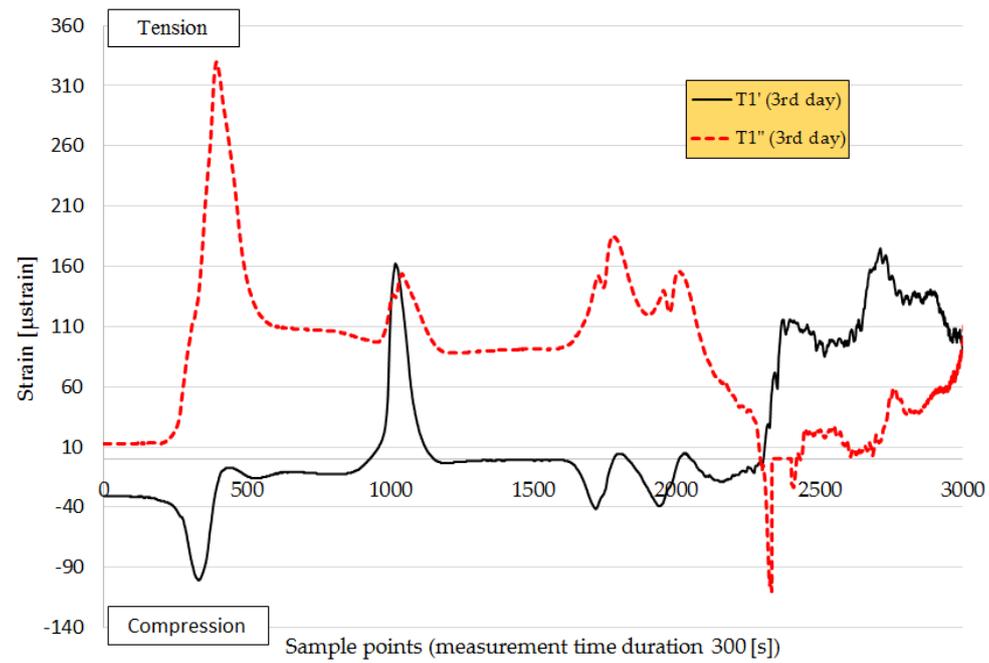
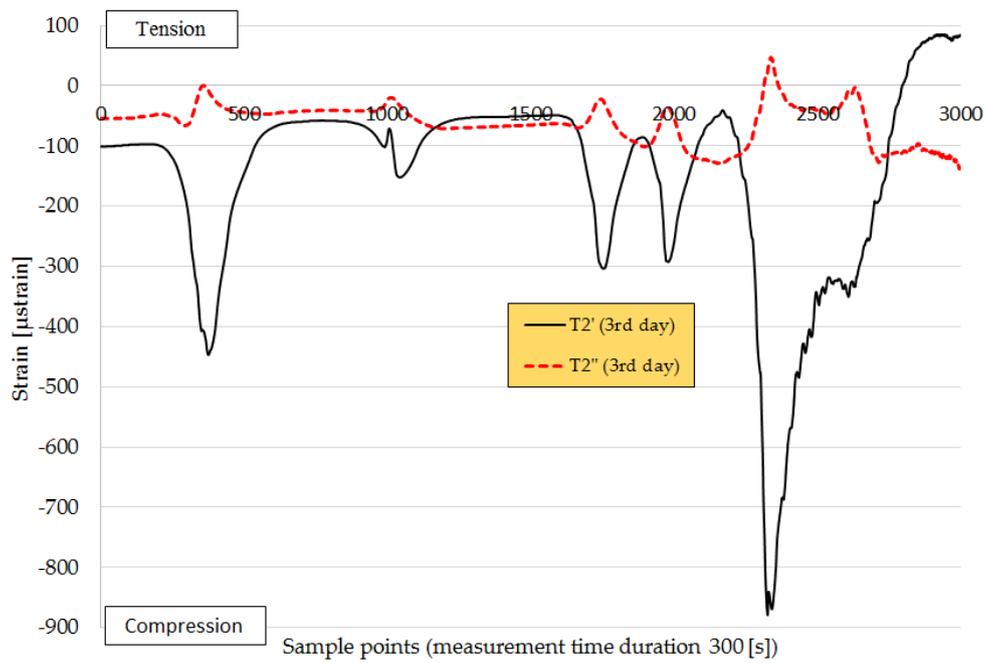
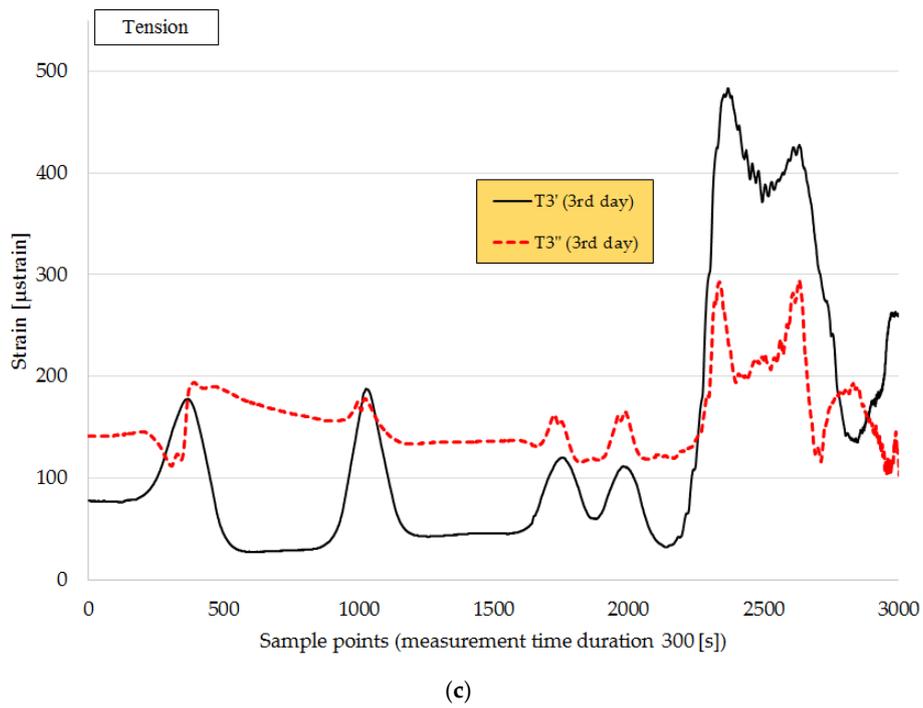
Figure 11. Strain values of sensors: (a) T1' and T1'', (b) T2' and T2'' at a temperature of 21 °C, and (c) T3' and T3'' at a temperature between 24 and 29 °C during the construction of the CyPaTs asphalt pavement on the third day.

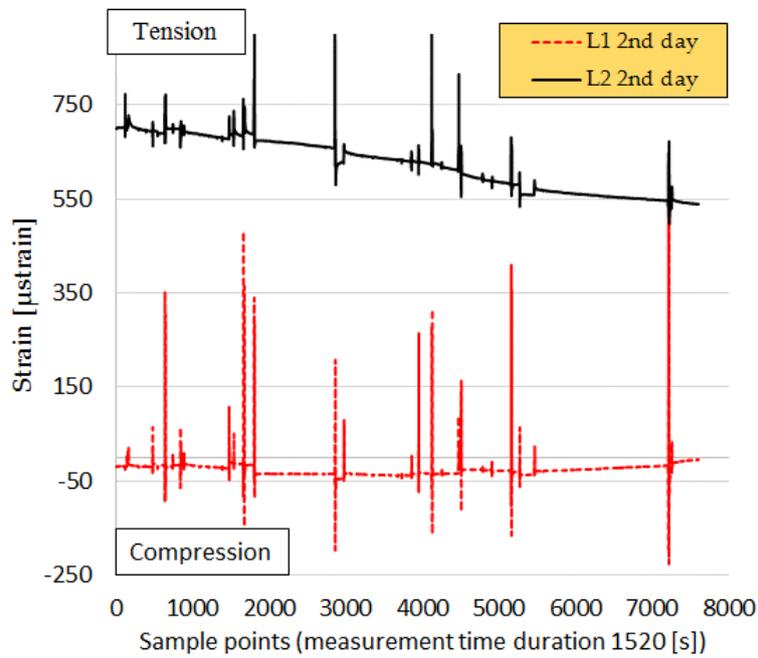
Figure 12. Strain values of sensors L1 and L2 during the construction of the CyPaTs asphalt pavement on the second day.

Figures 12 and 13 show the responses of the sensors in the longitudinal direction of the cross-section of FBG chains in transverse and longitudinal directions. In this case, the sensors located closer to the cross-section configurations of FBGs were selected for the analysis. It can be observed that the sensors located at the lower asphalt layer (AC-14) experienced compression, and the sensors in the second base layer detected tension (see Figure 13). In addition, a difference in the response of the sensors in the longitudinal and transverse directions can be observed. The strain peaks are higher in the longitudinal (L) directions than in transverse directions (T). The response of the sensor in the location L1 for all 3 days shows that it was under compression (Figures 7, 12 and 13), but when taking a closer look at the response of the sensor at location T1', in the transverse direction at the bottom of the first base layer (AC-14), it can be noticed that this sensor is under compression on the first day

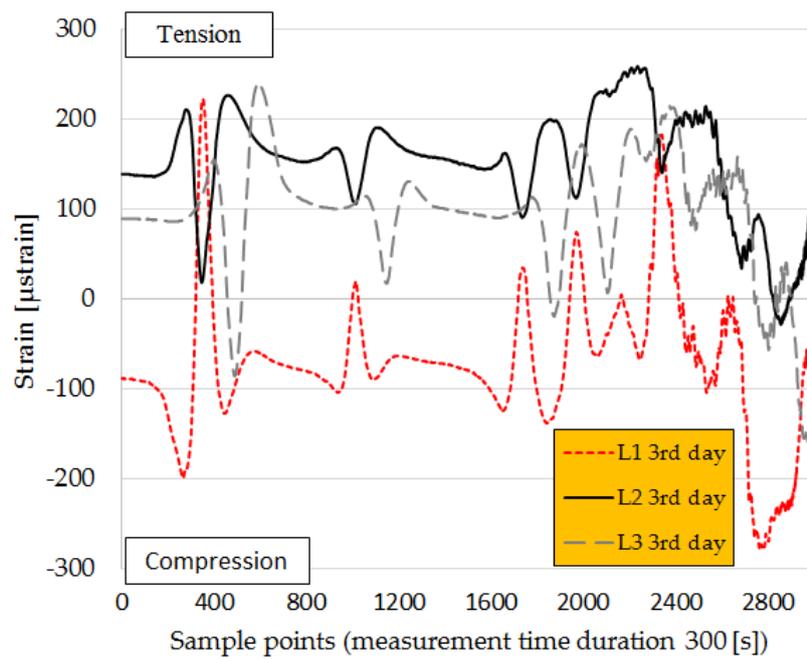
Figure 13. Strain values of sensors L1, L2, and L3 during the construction of CyPaTs asphalt pavement on the third day.

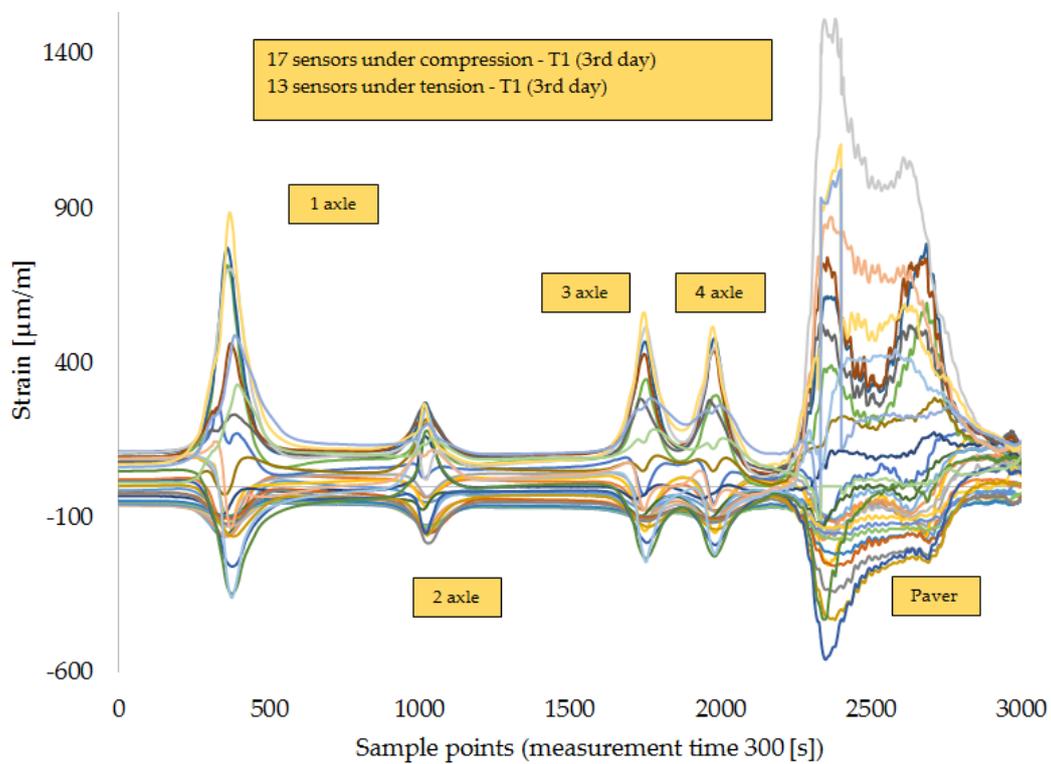
Figure 14. Monitoring of T1 on the third day of the paving process when the four-axle truck and the paver drove along the FBG chain of 30 DTG® (L1) embedded under the first base asphalt layer (AC-14) [17].

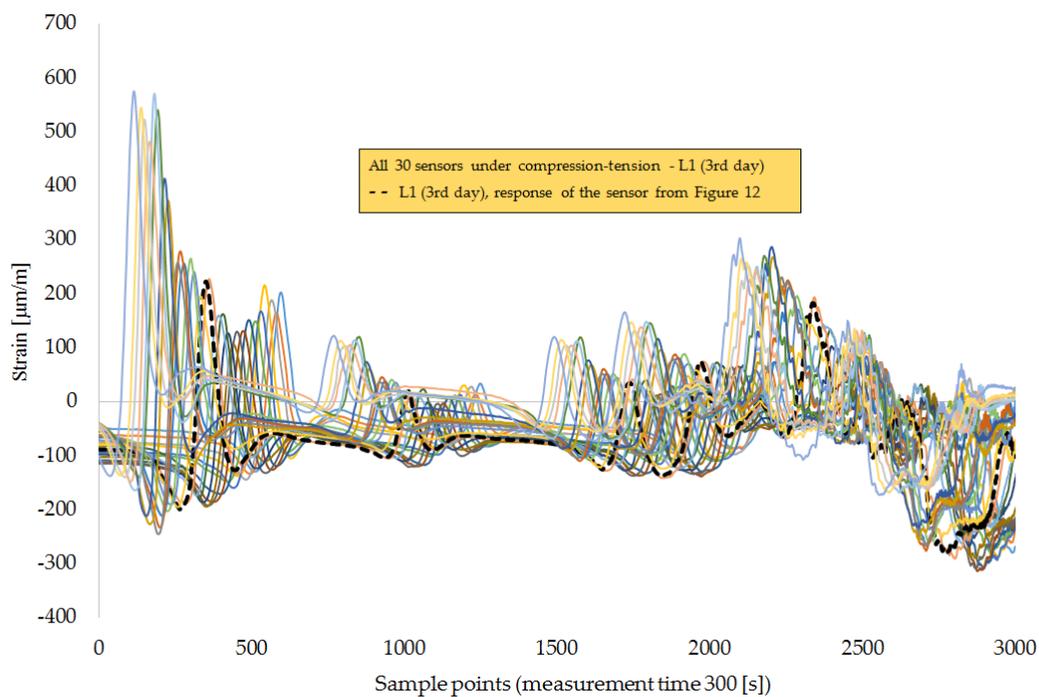
Figure 15. Monitoring of L1 on the third day of the paving process when the four-axle truck and the paver drove along the FBG chain of 30 DTG[®] (L1) embedded under the first base asphalt layer (AC-14).
